HIGH MISALIGNMENT CARBON SEALS FOR THE FAN DRIVE GEAR SYSTEM TECHNOLOGIES

Dennis Shaughnessy and Lou Dobek
United Technologies—Pratt & Whitney
East Hartford, Connecticut

2005 NASA Seal/Secondary Air Delivery Workshop

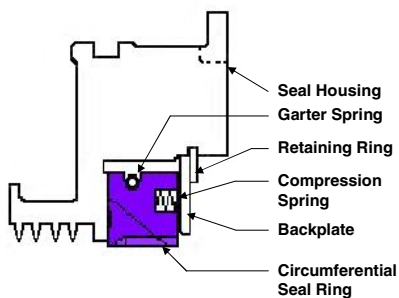
1-Piece Segmented Circumferential (Baseline Design)

- 1 Piece design resulted in wear rates that exceeded project limit goals.
- Base material (Carbon X) is suspect to be inappropriate for this application.
- Alternate design & material need to be investigated.

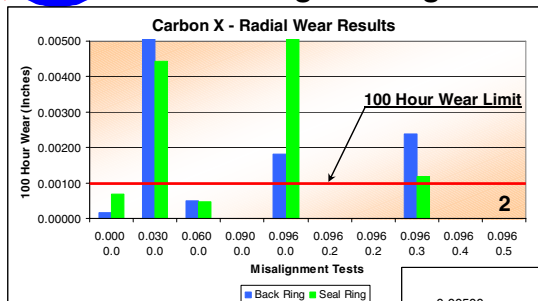
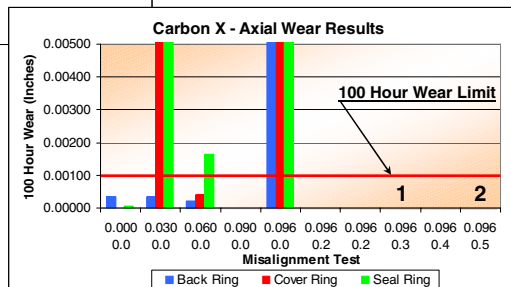
- Carbon X repeatedly exceeds 100 hour wear limit.
1. Excessive coking indicated negative wear.
 2. Test terminated after two attempts resulted in broken seal segments.

Carbon X repeatedly exceeds the 100 hour wear limit goal and testing was terminated after multiple failures.

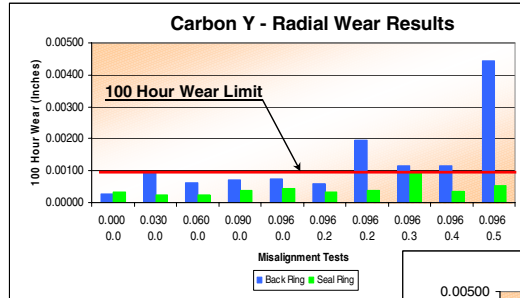
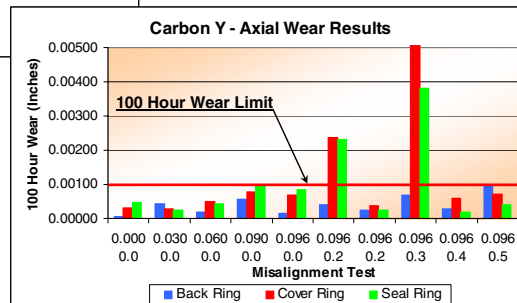
- All components using Carbon Y meets the 100 hour wear limit in Radial misalignment tests.
- Carbon Y components exceed 100 hour wear limit in axial misalignment tests. Mounting hardware damage identified.

Carbon Y meets the 100 hour wear limit under purely radial misalignment conditions. Seal retaining hardware suffered fatigue and failure during combination radial & angular misalignment tests. These failures are to be investigated at the potential reasons for the 100 hour wear limit to be exceeded.

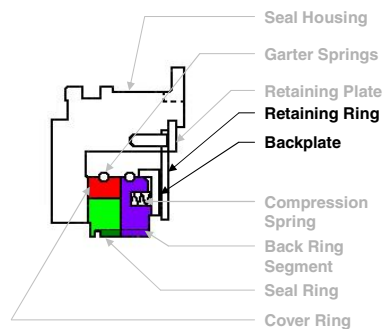
Backplate tang steadily wearing into slot of Retaining Ring. Current Seal Housing prohibited design change to increase Retaining Ring to the full thickness of the tang.

Photos of seal retaining hardware show the wear the occurred during misalignment testing.

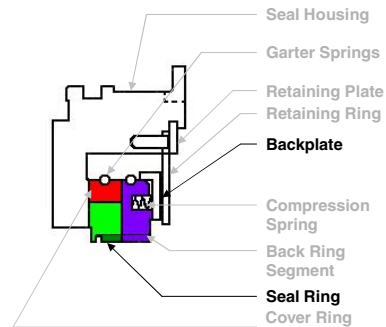
Seal Ring wear during test phase of advanced design misalignment tests

Backplate failure during test phase of advanced design misalignment tests

Backplate Key steadily wore into slot of Back Ring and Seal Ring. Modification increased the number of Keys from one to two.

Backplate stress crack identified after test with the largest combination of Radial and Angular misalignment. Modification increased the corner radii at the keys.

Photos of seal and associated retaining hardware show the wear and stress fracture that occurred during misalignment testing.

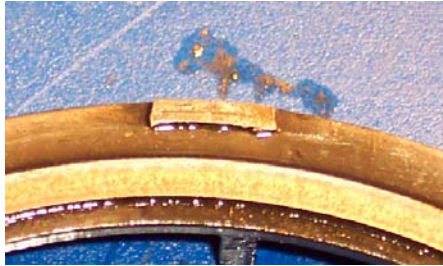
Backplate Tab Failure

Seal Ring Notch Wear

Back Ring Tab Failure

Photos of the seal assembly and signs of wear that occurred during misalignment testing.
